# Crane Tipover

*By R. John Phillips, P.E., CFEI*

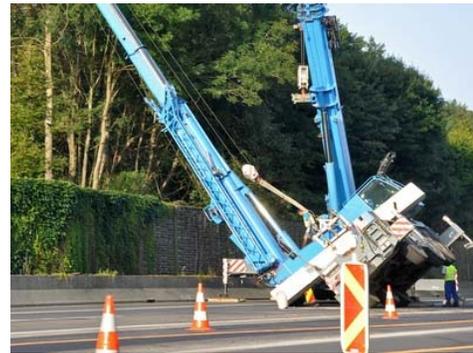
A truck mounted crane traveled to a bridge construction site to conduct several lifts. It made the first lifts successfully. On the second day at the site, the crane tipped onto its side while making a steel reinforced concrete panel lift that was believed to be safely within its capacity.

The lift involved a load and lift radius that were within the capacity of the permanent load chart mounted in the operator's cab. The crane Load and Moment Indicating (LMI) system, a computerized system that prevented the crane from being loaded beyond its safe capacity and warned the operator of impending overloads, did not prevent the lift or warn the operator of the impending tipover.

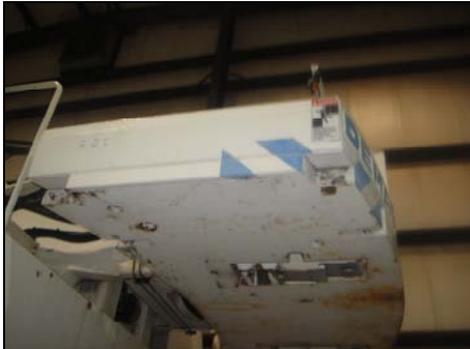
The investigation concluded that the crane tipped onto its side because it was loaded in excess of the appropriate load charts in the crane manual and the load charts were improperly programmed into the crane LMI system for full counterweight operation although less than the full counterweight load was actually in place.

**The base counterweight of a mobile crane without the removable counterweights that should be mounted to develop the full crane lifting capacity without tip over.**

The crane operator should have been trained and familiar with the reduced loads in the crane manual charts and have properly set up the crane LMI system for operation with only partial counterweights. Proper counterweights would have balanced the crane against tipping in response to the lift load and radius. This condition would have been readily identifiable and prevented if the crane operator had used the proper load chart in the crane manual or had properly set up the crane LMI system.
