FORENSIC ENGINEERING ANALYSIS OF

# LOW TEMPERATURE IGNITION OF WOOD

**Jerry R. Tindal, MS, P.E.**  
THE WARREN GROUP, INC.

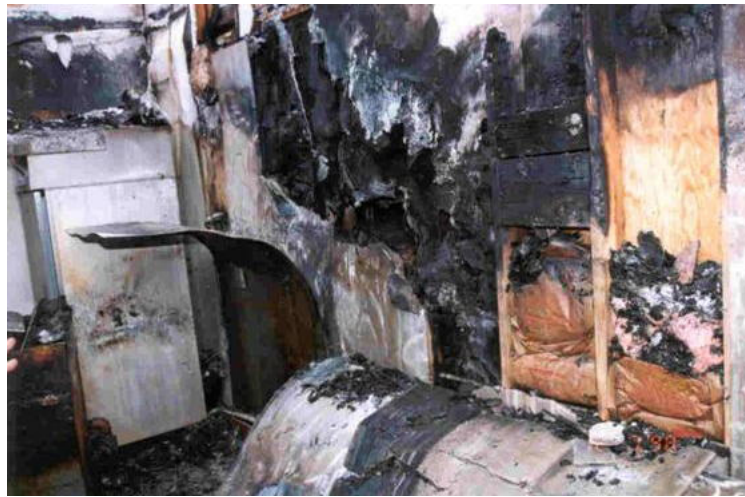
**FIGURE 1**

Origin area in the wall behind the cheese melter with the melter removed.

The only competent ignition source identified within the region of fire origin was excessive conduction heat transfer into the horizontal wood blocking material within

melter mounting bracket. The fire damage in the wall cavity behind the cheese melter exhibited characteristics of a long-term smoldering fire and potential self-heating of the wood. The wood blocking and studs were severely damaged in and around the area where the far left lag bolt of the mounting bracket was located. Figure 4 depicts the back of the cheese melter after it was removed from the wall. The pattern on the back of the cheese melter indicates a region of high temperature corresponding to the region of fire origin within the wall. Figure 5 depicts the wood blocking in the area around the far left lag bolt. An investigation into the cause of the fire was initiated.

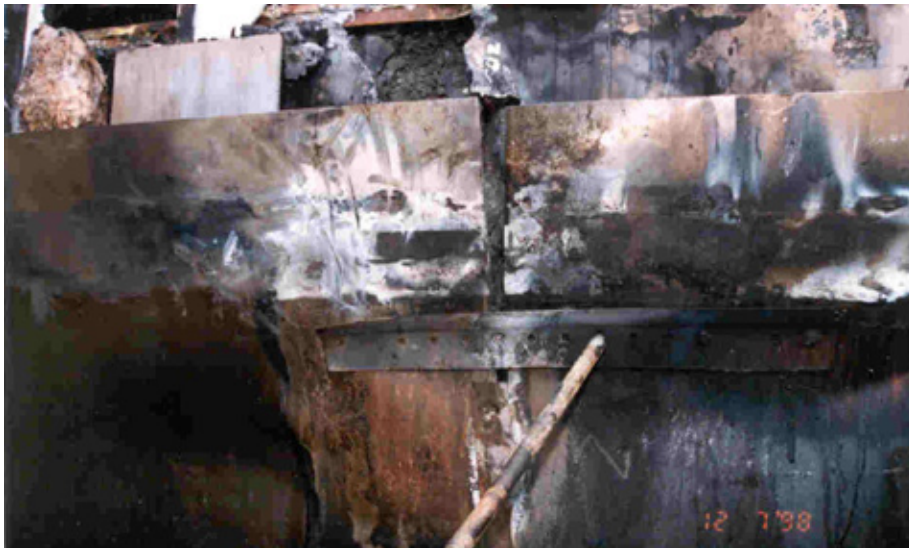
**FIGURE 2**  
Origin area with the wall reconstructed and the left cheese melter hanging bracket held in place.

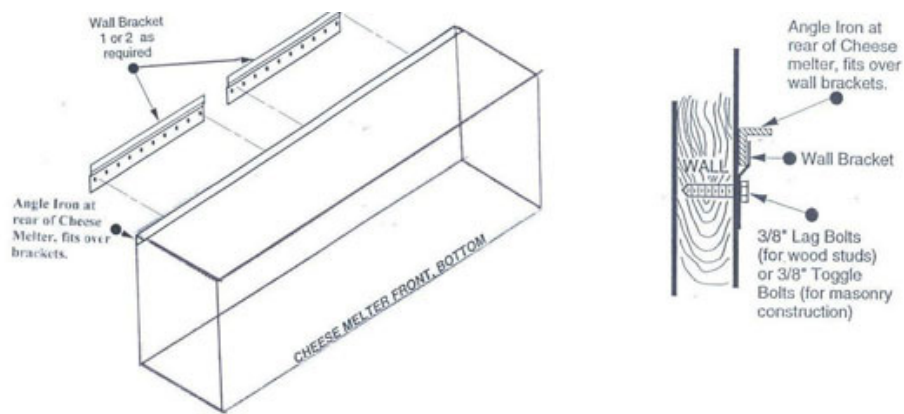
**FIGURE 3**  
Cheese melter manufacturer's mounting instructions excerpt.

The manufacturer specified installation of the cheese melter on the mounting bracket produced only a gap of 3 inches between the back of the cheese melter and the wall for hot gases produced by cooking appliances beneath it to pass through and into the hood above.

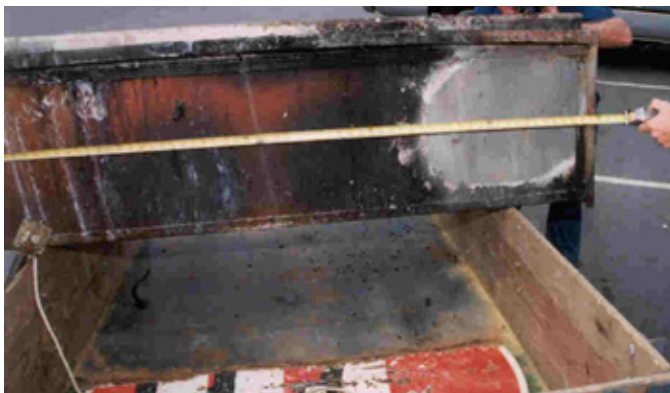
**FIGURE 4**  
A view of the back of the cheese melter. The heat pattern on the right corresponds to the origin area within the wall.

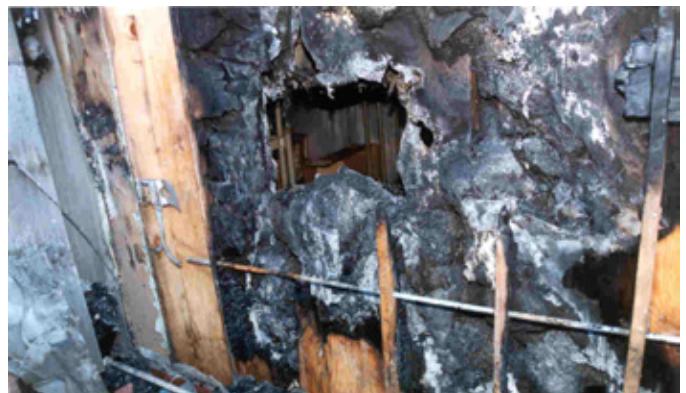
**FIGURE 5**  
A close up view of the origin area depicted in Fig. 1. The burned hole through the wall corresponds to the heat pattern on the back of the cheese melter.

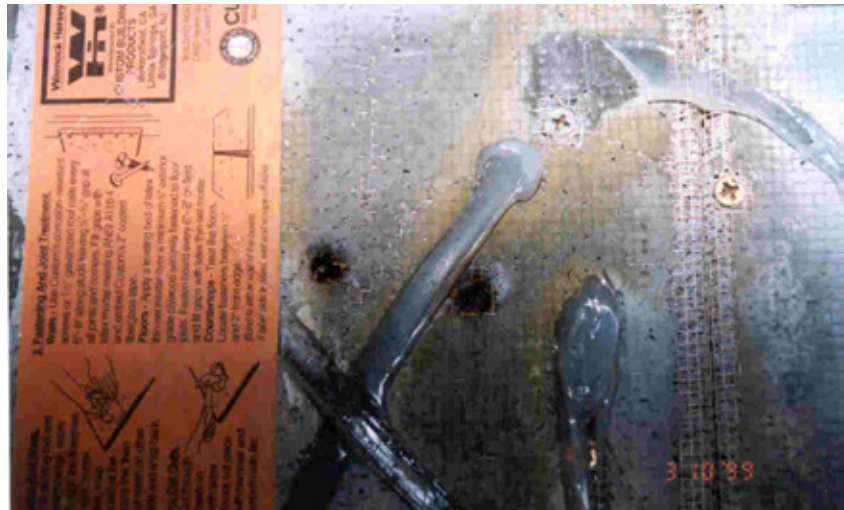
In all three restaurants, significant heat damage was observed on the wood and wallboard where the leftmost lag bolt of the cheese melter mounting bracket penetrated the wall. Figures 6, 7 and 8 respectively depict some of the heat damage observed at the Alabama, Florida and Tennessee restaurants.

**FIGURE 6**  
*Trussville, Alabama.* Heat damaged Durock® covering the wood blocking where the cheese melter hanging bracket lag bolt penetrated the wall.

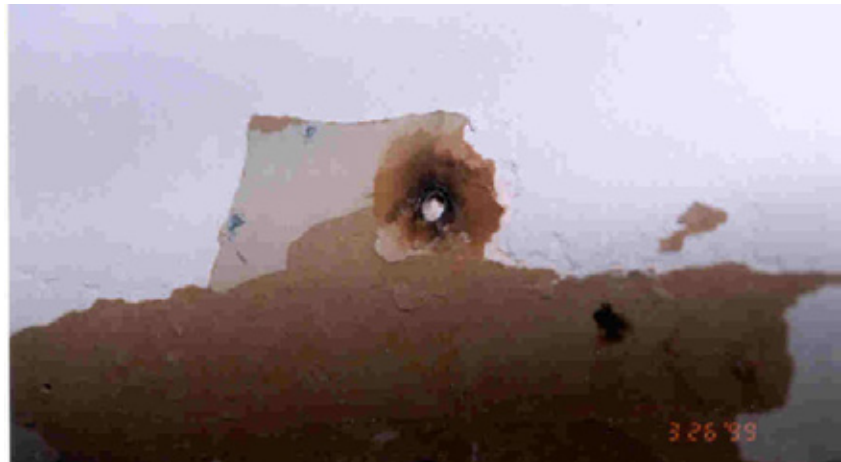
**FIGURE 7**  
*Niceville, Florida.* Heat damaged drywall covering the wood blocking where the cheese melter hanging bracket lag bolt penetrated the wall.

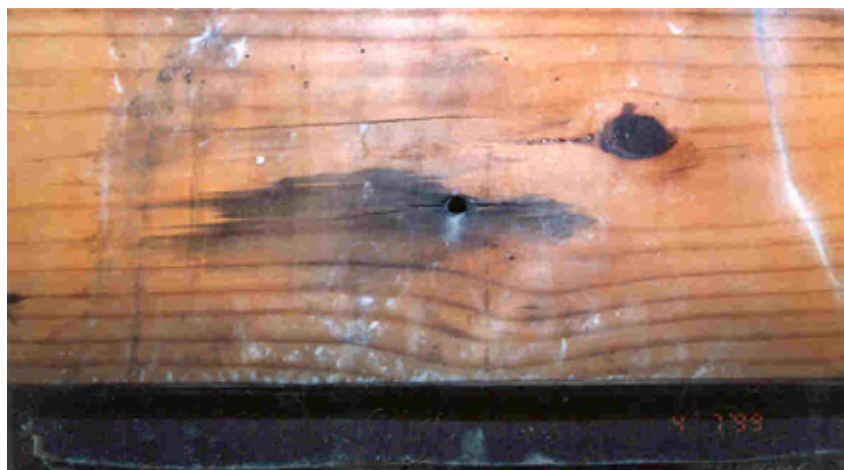
**FIGURE 8**  
*Tullahoma, Tennessee.* Heat damaged wood blocking where the cheese melter bracket lag bolts penetrated the wall. Wall coverings removed.

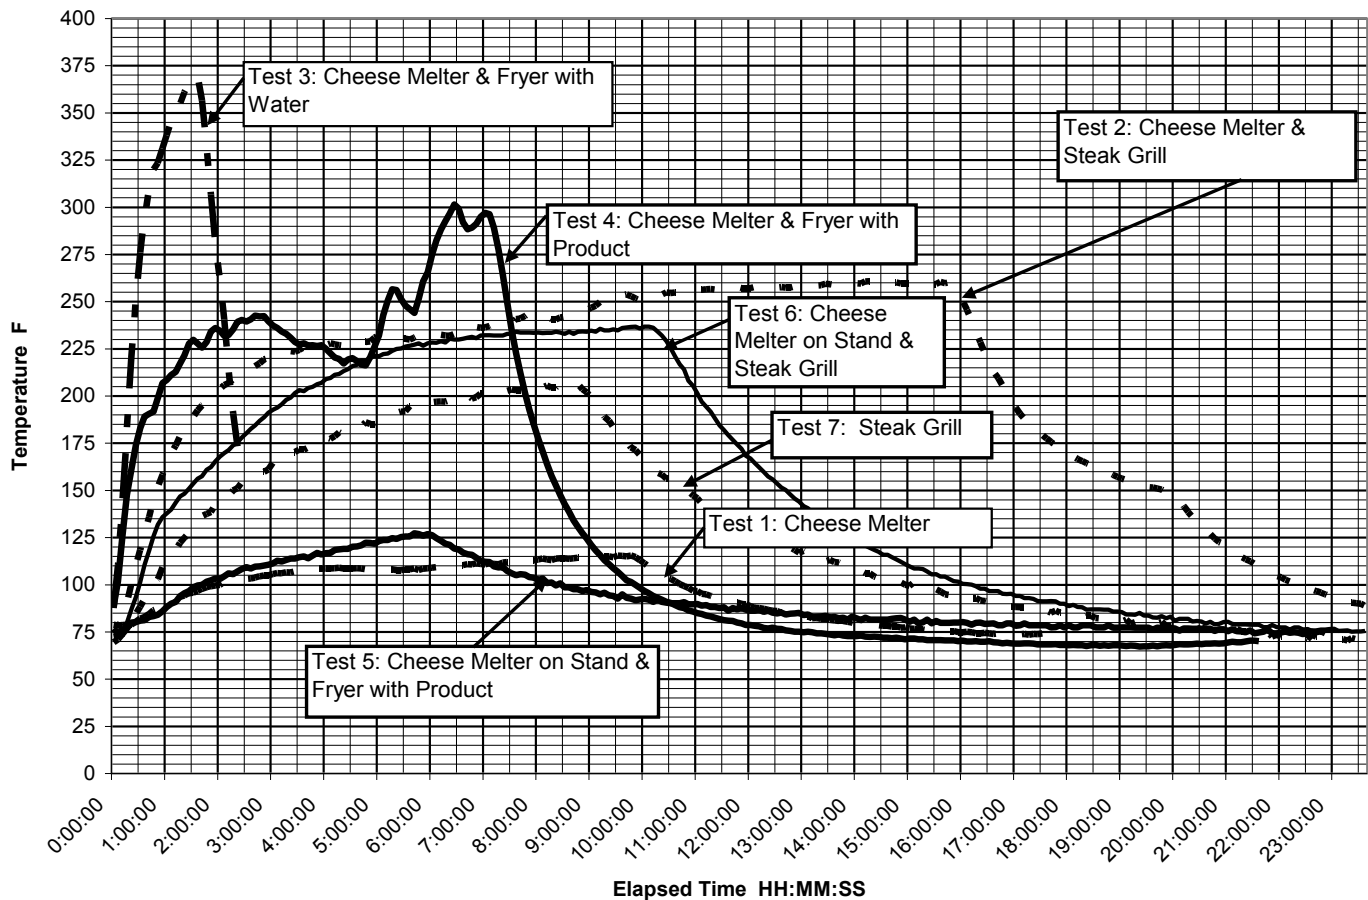
**FIGURE 13**

Test two, simulating the Clemson, SC store, indicates that the temperature on the front surface of the 2 x 12 wood blocking where the far left bolt was installed reached as much as 265°F with an average wood block temperature of 256°F when the cheese melter was operated in conjunction with the charbroiler.

**Time vs. Temperature Graph** at front of wood blocking – Point A

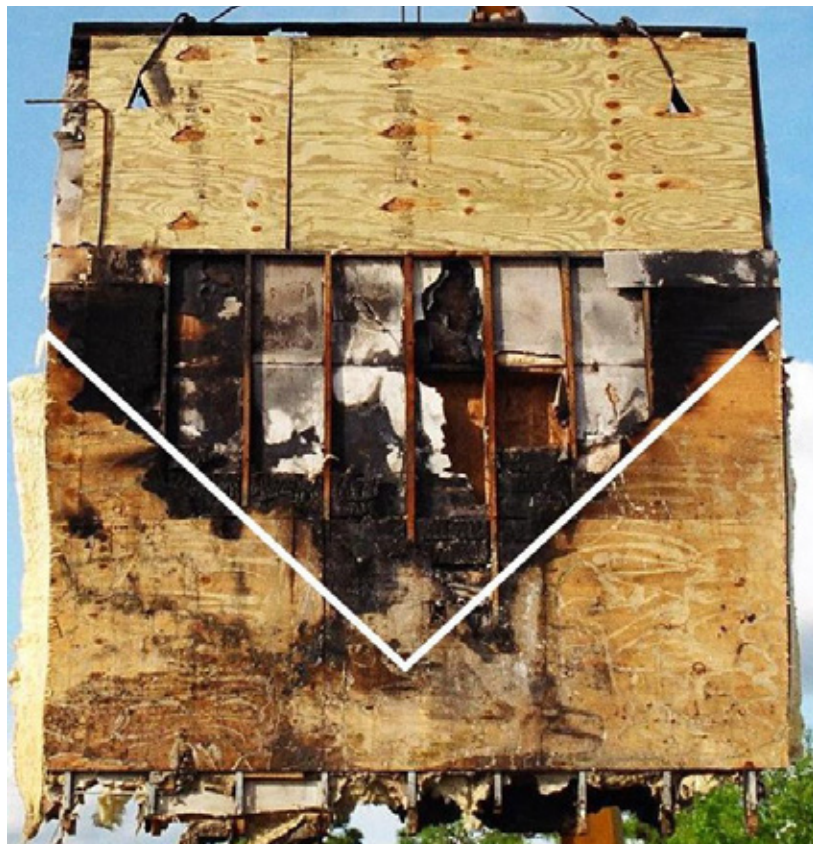
FIGURE 14

A view of the cookline wall being lifted from the restaurant. Note the typical v-pattern on the wall where the cheese melter had been located.

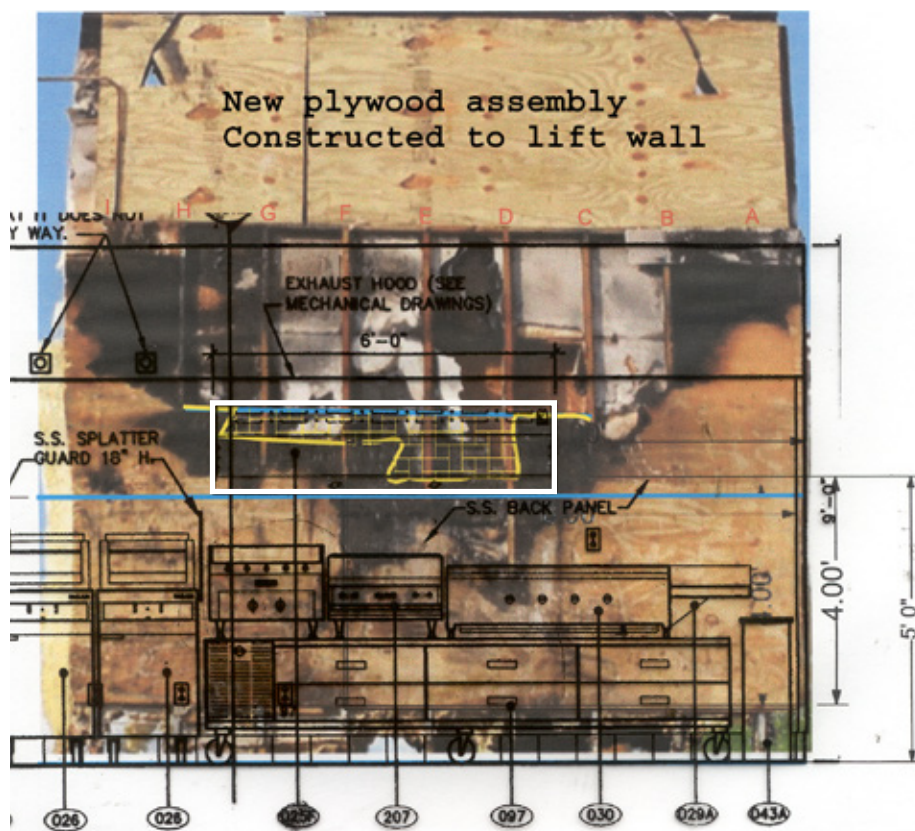
**FIGURE 15**

In the case of the Sebring restaurant, the contractor grossly failed to follow the construction plans in building the wall. The plans included multiple detailed drawings clearly illustrating and stating how the wall was to be constructed with metal studs and a metal header to mount the cheese melter bracket to it, as well as noncombustible Durock sheathing. Instead, the contractor

Cookline wall with scaled transparency overlay of the cooking equipment. The cheese melter location is outlined in white.

used 2 x 12 wood blocking between metal studs, covered the wall with plywood sheathing and lag bolted the bracket to the wall as per the cheese melter manufacturer's installation instructions. At several points in the wall where the bolts penetrated into the wood blocking, the blocking was totally consumed.
