FORENSIC ENGINEERING ANALYSIS OF

# LOW TEMPERATURE IGNITION OF WOOD

**Jerry R. Tindal, MS, P.E.**  
THE WARREN GROUP, INC.

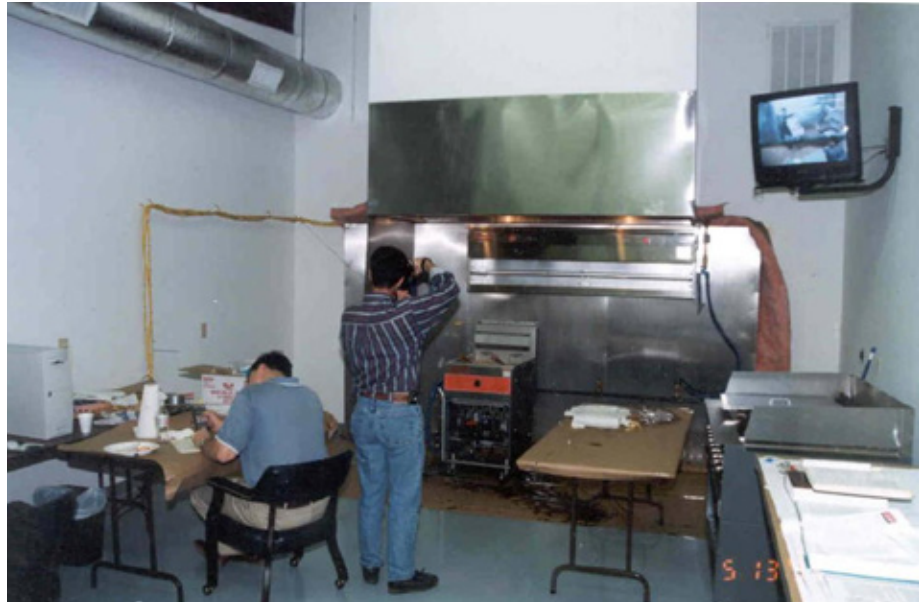
**FIGURE 9**

Test wall set-up and equipment configuration for deep fat fryer and cheese melter test.

The wall was installed on castors and hinged at one end, allowing us to swing the wall out and access the back side for instrumentation, examination and to vary insulation use in the wall during the tests. Figure 9 illustrates the test wall set-up for one of the test variations run. The hood was configured to match the exhaust rate and velocity specifications of the restaurants.

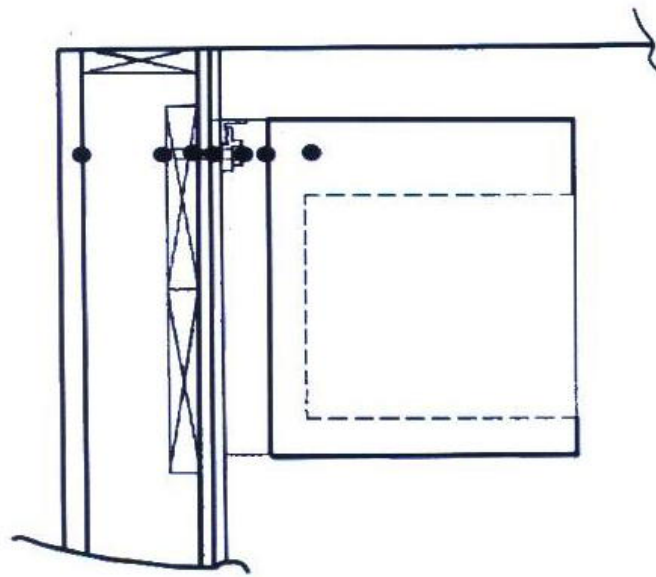
The wall and the cheese melter were instrumented with 7 thermocouples along its profile at 4 different parallel locations along the wall face, for a total of 28 thermocouples. The four instrumented face locations of the wall were referenced as A, B, C and D. Figures 10 and 11 depict the location of the thermocouples in the test apparatus set-up.

**FIGURE 10**  
Cross-sectional view of wall and cheese melter. Thermocouples locations through the cross-section are marked by black dots. The wall and cheese melter were instrumented with 4 sets of 7 thermocouples per set.

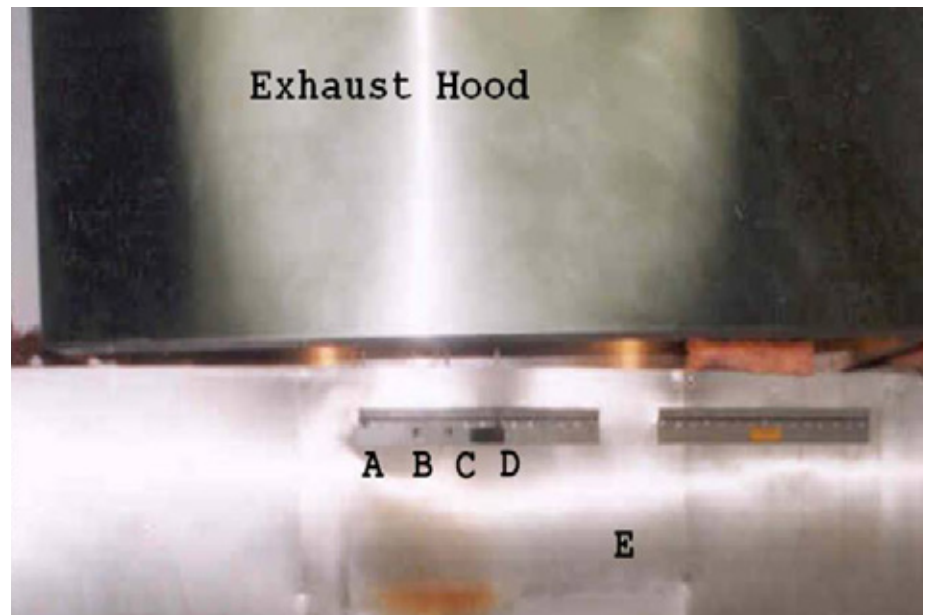
**FIGURE 11**  
Test wall front view with mounting brackets installed and melter removed. Indicated are thermocouple set locations A, B, C, D and thermocouple elevation point location E.

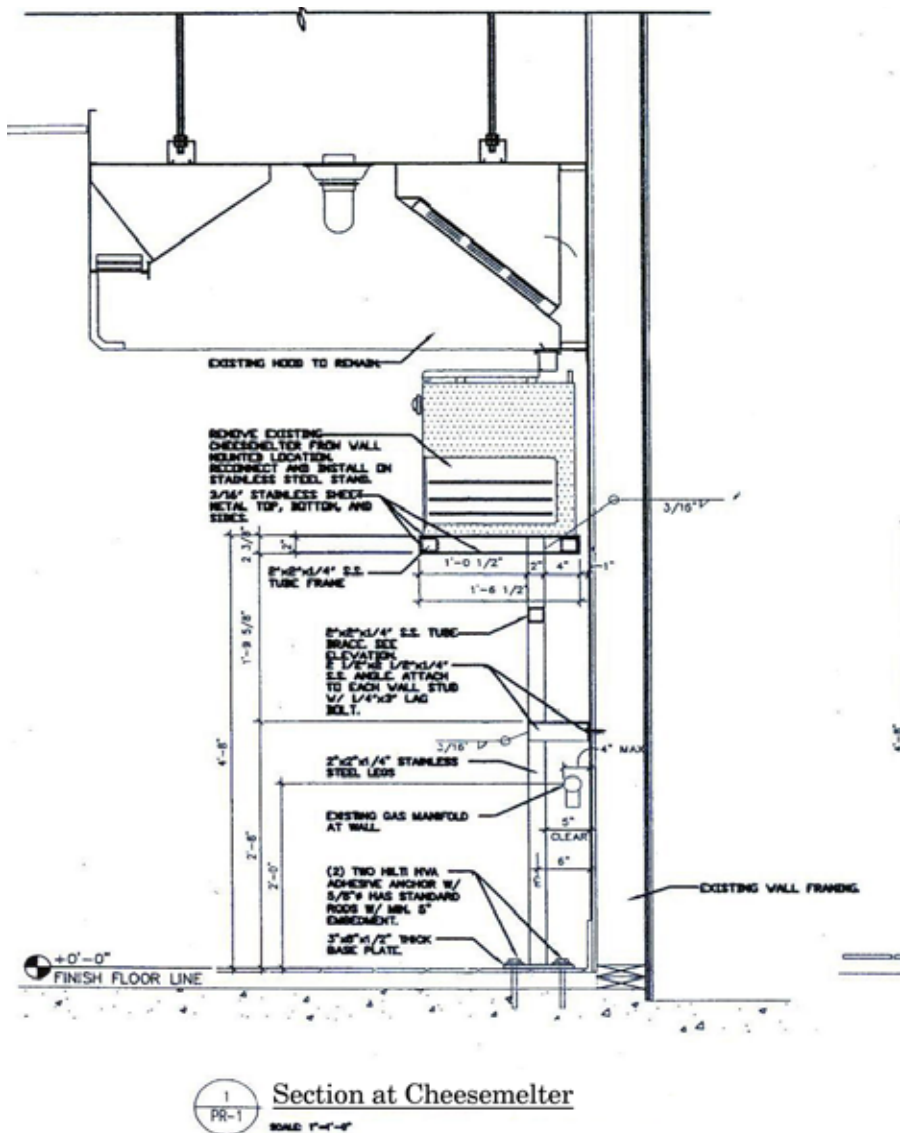
A total of seven tests were completed. The tests are described and the results summarized below. Note that during tests 5, 6, and 7, a third thermocouple location, referenced as Point E, was added. This thermocouple measures a single point temperature at the interface of the wood blocking and Durock wallboard at an elevation point parallel to the back surface of a free standing stand shelf assembly that was designed and added to the test apparatus to support and offset the cheese melter from the wall. The stand assembly set-up is depicted in Figure 12.

**FIGURE 12**  
Section View. Cheese melter and stand.
