Settling Complex Claims with the Involvement Matrix

By Jeffery H. Warren, Ph.D., P.E., CSP

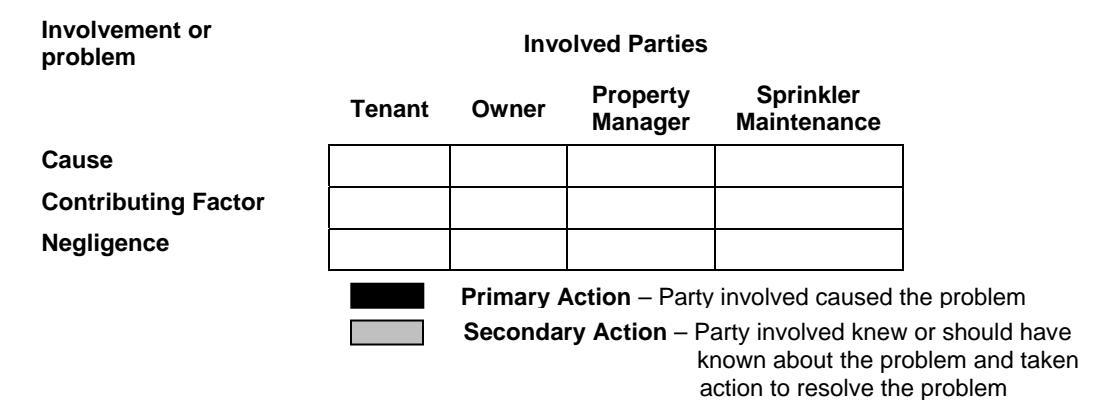
First, list the problems, contributing factors, or involvement of the various parties down the left side of a spreadsheet. Second, list the involved parties along the top. Then, in the matrix, use the evidence to assign one of three levels of involvement for the problem.

Primary Action = 2 points (black box) Secondary Action = 1 point (gray box) No Action = 0 points (clear box)

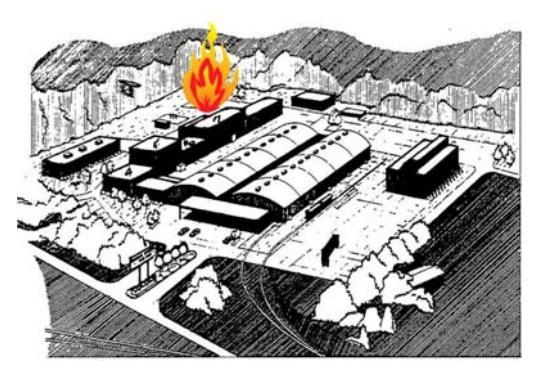
The Involvement Matrix shown below is a graphic depiction of the results of comparing the problems with who did or did not do what they should have done. Tenant No.1 gets black boxes because the origin of the fire was in his equipment. The equipment was not properly located or cared for. Tenant No.1 also receives a black box for the sprinkler system not working because he ignored employee reports about the lack of water in the sprinkler system.

In simple terms, the party with the most black or gray in their column loses.

Tenant No. 1	Owner	Property Manager	Sprinkler Maintenance
Origin in Filter House				
Filter not cleaned				
Filter in building				
Sprinkler didn't work				
Valves not locked open				
Sprinkler not inspected				
Lack of water				
Supply pond drained				
Isolation valves closed

The owner got gray boxes for the sprinkler system not working and for not having enough water available. Additionally, he did not have an effective management system in place to restore and maintain the facility's fire suppression systems.

The owner gets a black box for draining the pond because he ordered the pond dam breached, thinking that he was eliminating the potential liability of an unattended body of water.

The property manager was assigned gray boxes for the sprinkler system and lack of water because he didn't have an effective management system in place to ensure that the systems were understood and properly inspected and maintained. He was assigned

black boxes for the disabled sprinkler system and for not properly inspecting the systems because he was hired by the owner to do it.

The sprinkler system maintenance company was assigned a black box for the sprinkler system not working because they were hired to restore the system but failed to even propose a program of necessary work. They were given a gray box for the lack of water because they failed to identify the need for or the presence of the auxiliary water supply in their inspections of the system.
